**TECHNOLOGY FOR REPAIRING DAMAGED 3LPE INSULATION
WITH ANTICORRAY REP MATERIALS
ACCORDING TO EN-ISO21809**

3.1 TECHNOLOGY FOR REPAIRING DEEP DAMAGES REACHING THE SURFACE OF THE PIPE (METAL), SIZED LESS THAN 10 CM²

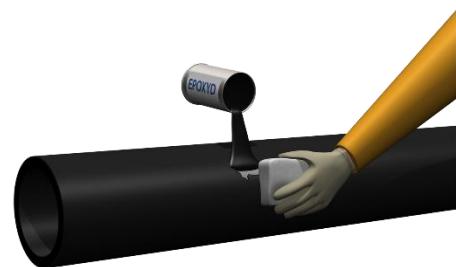
- Heat up the place under repair with a burner to reach 70 ÷ 80°C (3LPE insulation – burner flame).
- Mix components A and B of ANTICORRay Primer 801 epoxy primer thoroughly.
- Apply primer to steel surface.

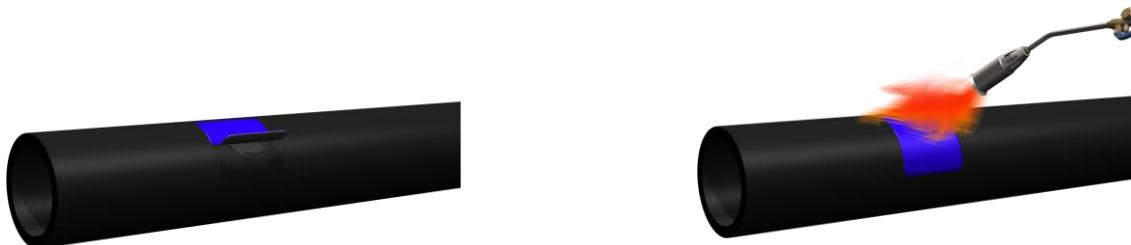
- Place the patch on the place under repair with 50 mm overlap on the factory coating.
- Hold the patch in the burner flame (3LPE).
- Remove air bubbles, if any, using a silicon roller.
- Stop heating up the patch when an adhesive flash has appeared in the periphery.
