ANTICORRay REP

CORROSION PROTECTION MATERIALS

Repair hot-applied patch C50 in accordance with EN12068 and DIN 30672.

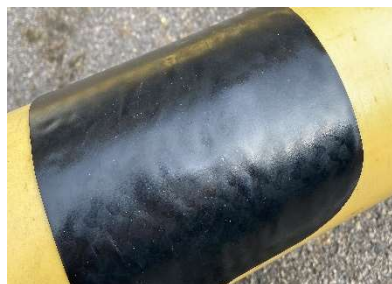
PRODUCT DESCRIPTION

Carrier:

- Cross-linked high density polyethylene (HDPE), featuring high mechanical strength.

Adhesive:

- Hot melt resistant to shearing stresses.

Colour:

- Black.
